Wind Turbine Slip Ring Repair

The three slip rings on this 480 Volt, 28 Amp Westinghouse WWG-0600 Wind Turbine Generator were repaired in-situ, approximately 100 feet above ground, with the portable SIFCO Process of selective (brush) plating.

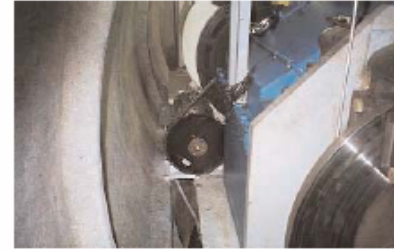
Rotating the Shaft

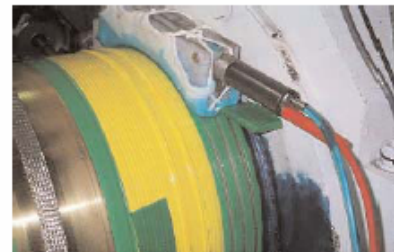
Plating Copper

These photographs show how the slip rings on the wind turbine were repaired in place. A thickness of 0.030" of copper was brush plated to resize the worn diameters. The grooves were then dressed back with a standard file and sandpaper until plan dimensions were achieved. After dressing the plated copper deposit, 0.003" thick layer of silver was then brush plated for improved conductivity.

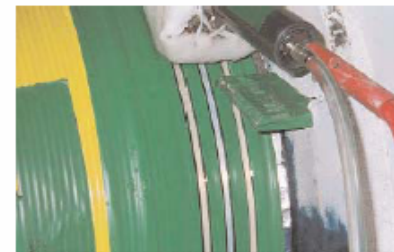
Plating Silver

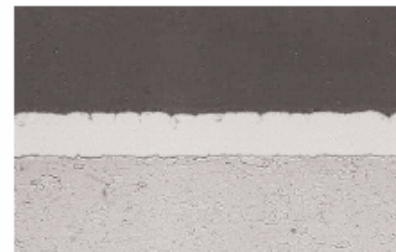
Silver Deposit 200X
