SIFCO SELECTIVE PLATING APPLICATION EXCHANGE PROGRAM

REFERENCE NUMBER: 96008

DATE: 23 February, 1996

Rod Metzger Repairs Rolls for Printing Press

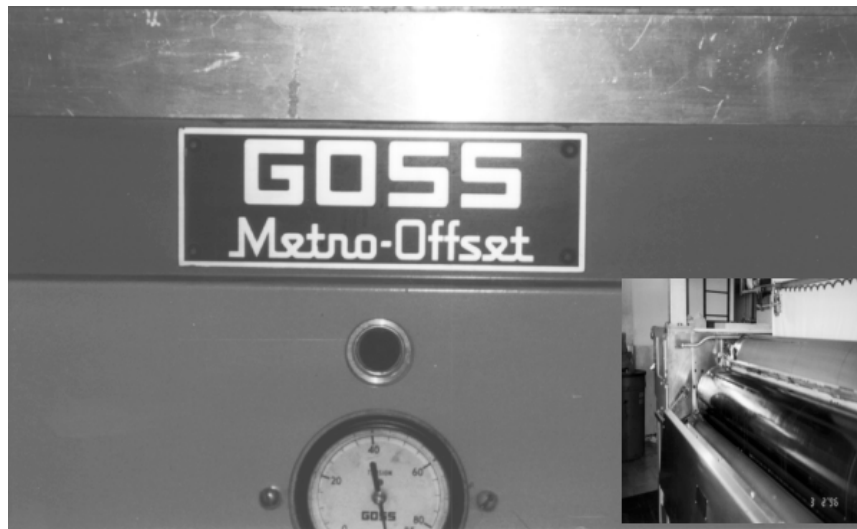
The roll for this Goss Metro Offset Press had a 0.025" deep defect that was 3/4" wide and 1 1/2" long. The defect was filled with 2050 Copper and capped with 2043 Cobalt. The photos below show the repair sequence.
