## Printing Industry Applications

### Repair damage to plate, blanket and impression cylinders

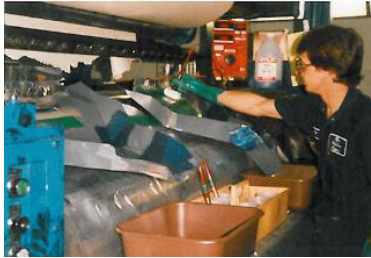
- Expose damaged area
- Dress sharp edges
- Mask to isolate damaged area
- Fill defects with copper
- Dress copper & polish to blend
- Cap repair area with hard, wear resistant deposit

- In-Situ Repairs
- Reduce Downtime
- Reduce Teardown & Shipping Costs
- Reduce The Need For Post Plating Machining
- Make Permanent Cost Effective Repairs
