Cavitation Resistance of Selected Copper Alloys

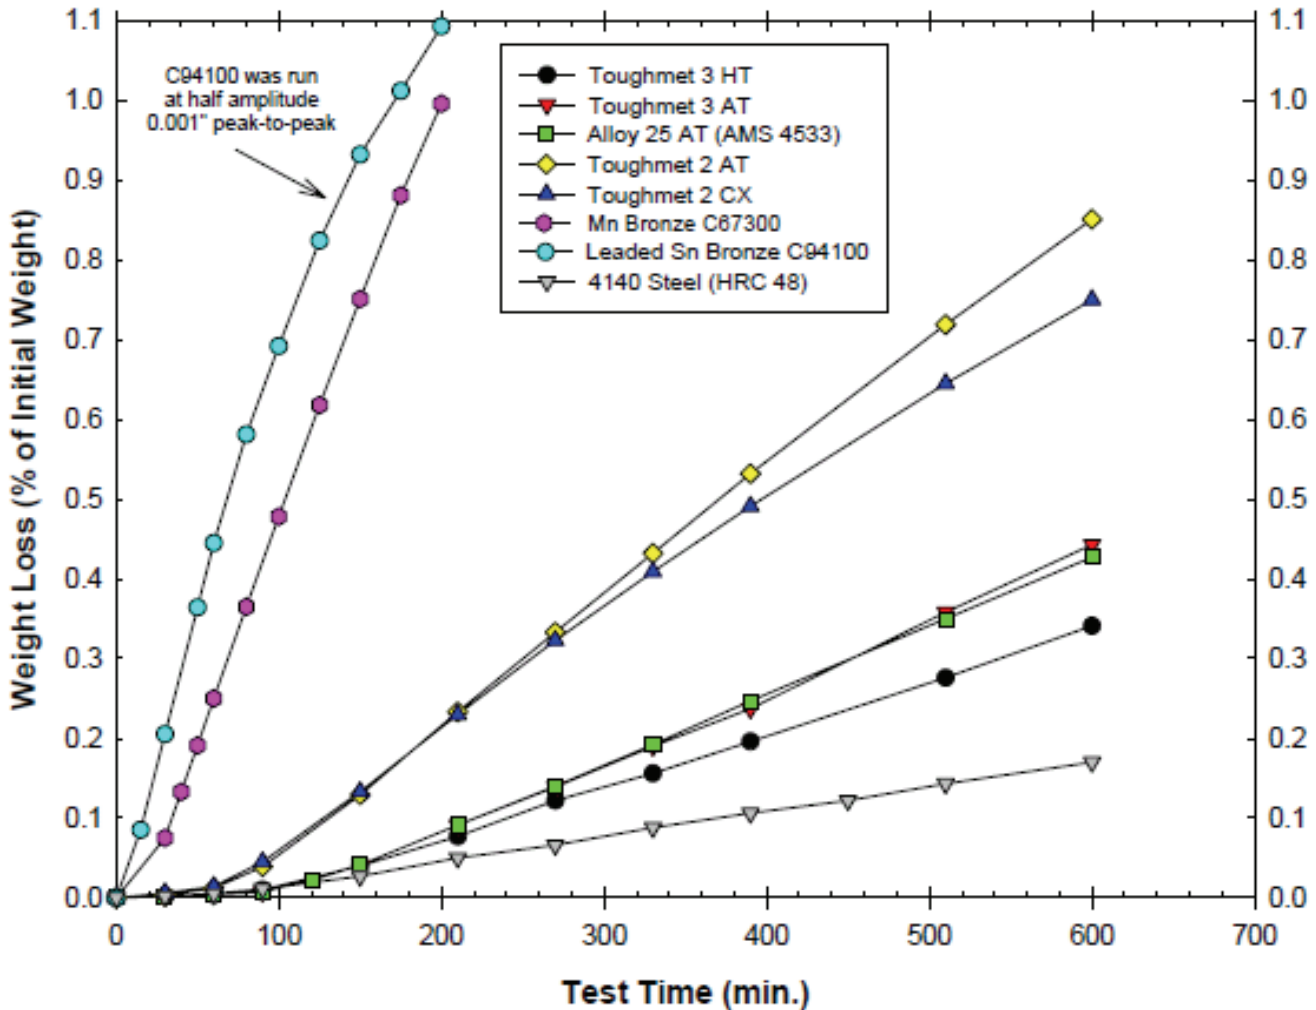
The results are shown in the graph. Several of the alloys are commonly used in cavitation prone environments,

however, they performed poorly in the test. The manganese bronze (C67300) showed the greatest weight loss and most rapid erosion of the alloys tested. Exceptionally rapid damage was observed on the high-lead tin bronze alloy (C94100). The damage accumulation was so extensive with this alloy that the excitation amplitude was reduced to one half of the amplitude used for the other alloys to complete the tests.

The lowest weight loss and highest performance was demonstrated by ToughMet 3 and Alloy 25, followed by the ToughMet 2. These alloys are among the highest strength copper alloys commercially available. The incubation time to initiate appreciable cavitation weight loss was also highest for these three alloys. As a reference, the high hardness 4140 steel showed a shorter incubation period compared to ToughMet 3 and Alloy 25.

A standard practice is commonly used to evaluate metals for cavitation resistance. ASTM G32, “Cavitation Erosion Using Vibratory Apparatus”, subjects a metal to cavitation in deionized water. This method is often used as a screening test to compare metal erosion from cavitation damage in a controlled environment. External factors such as dissolved or suspended particles, galvanic effects or corrosive environments are not covered by this test and should be treated as application specific. A series of copper alloys were subjected to this test procedure to compare, empirically, the resistance to cavitation damage in an inert environment. The alloys chosen are hardened by either solid solution, precipitation or spinodal decomposition and represent a wide range of strengths. Several of the alloys tested are commonly used in applications where cavitation is a common failure mode. A reference material, 4140 steel, was used to baseline the test results.
